Using NDE Diagnostics to Monitor the Deformation of an Octet Truss Lattice under Constant Compression Loading

David Moore, Sandia National Laboratories Albuquerque, New Mexico

Elliott Jost (PhD Student), and Dr. Christopher Saldana

Georgia Institute of Technology, Atlanta, Georgia

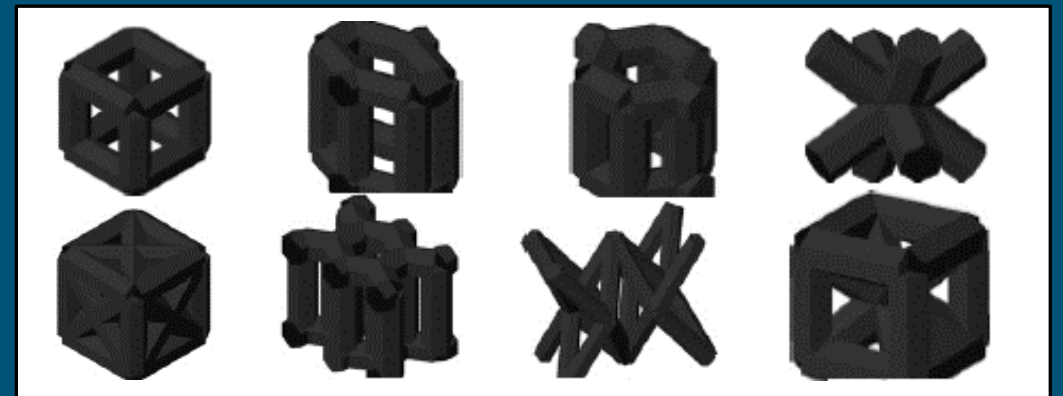
Periodic, high strength-to-weight ratio structures made possible through AM technologies.

- 36 struts/cell x (10 x 10 x 10) cells = **36,000** individual struts

Cell Types: Gyroid, BCC(Z), FCC(Z), Octet.

Material: Stainless Steel 316-L

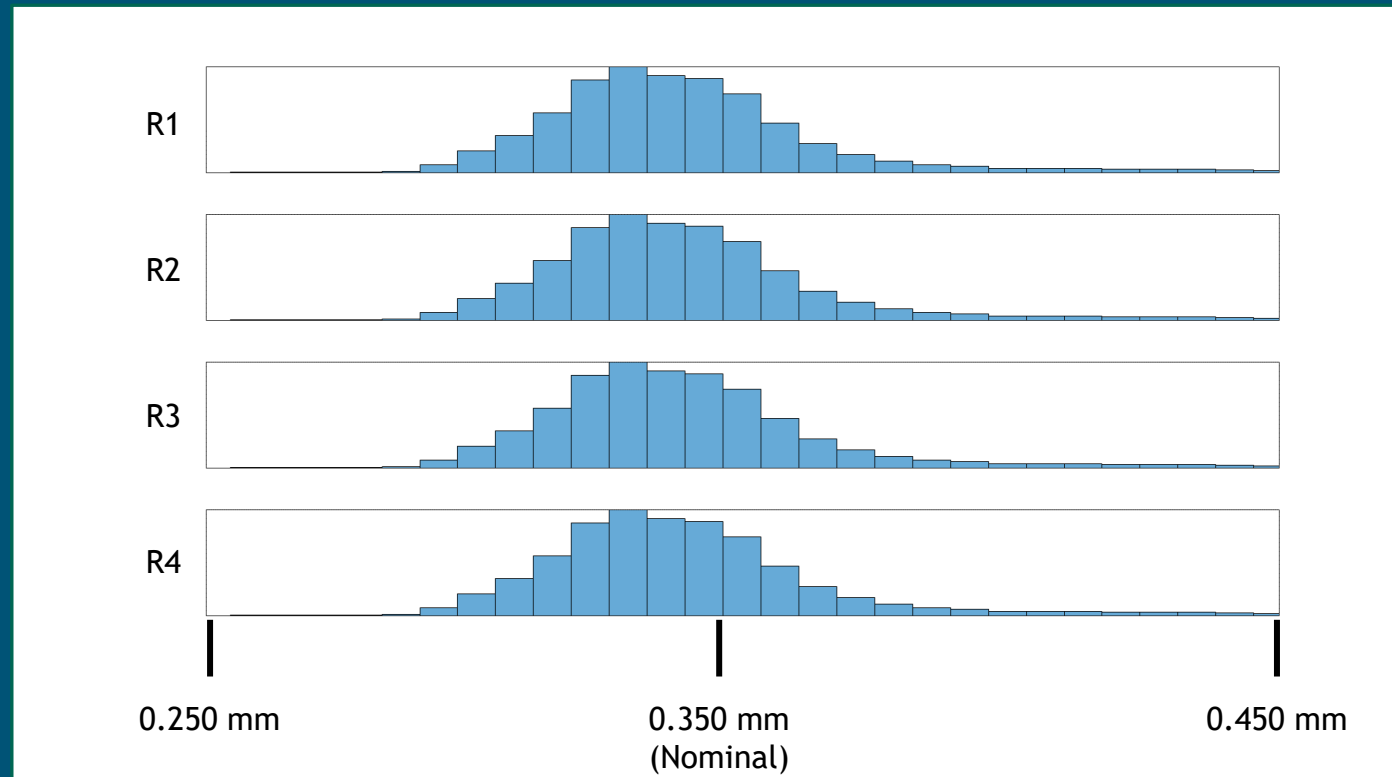
Lattice Characterization – Strut Thickness Measurement

Strut thickness was measured using 3D image processing techniques on the segmented CT volume using Volume Graphics software.

Ensuring struts are properly sized is important to quality control and parts performing as intended. Several regions were selected to gather statistics (R1 – R4).

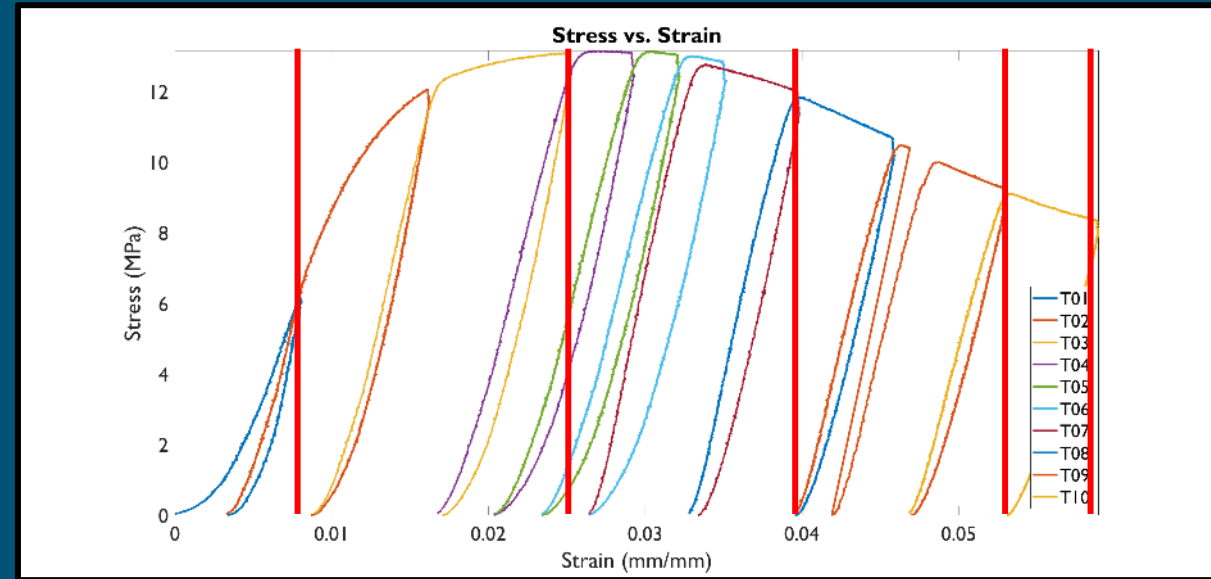
Sample 2 Deformation Summary

There is a preferred failure plane in the lattice structure. The lattice always fails at a free boundary condition. It appears that the failure is caused by a bending of a strut at a node to strut interface.

There is a preferred failure plane in the lattice structure. The lattice always fails at a free boundary condition. It appears that the failure is caused by bending of a strut at a node-to-strut interface. Computed tomography can be used to track the failure of lattices during compression testing.

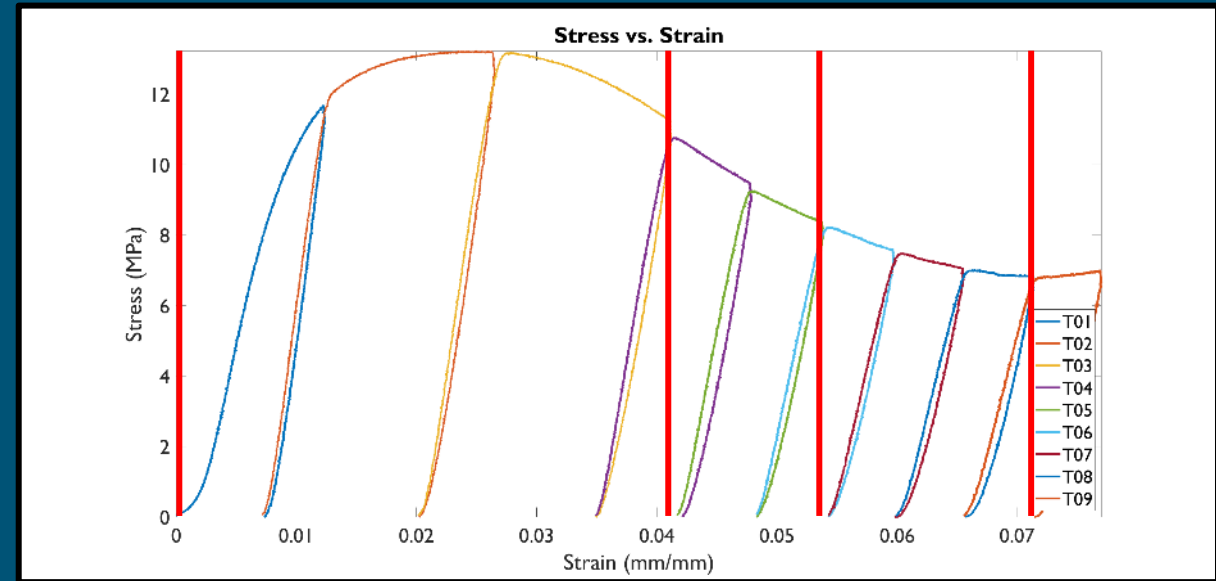
Sample 3 Deformation Summary

There is a preferred failure plane in the lattice structure. The lattice always fails at a free boundary condition. It appears that the failure is caused by bending of a strut at a node to strut interface. The four red lines to the right are where the strains were recorded and the CT inspection was taken.

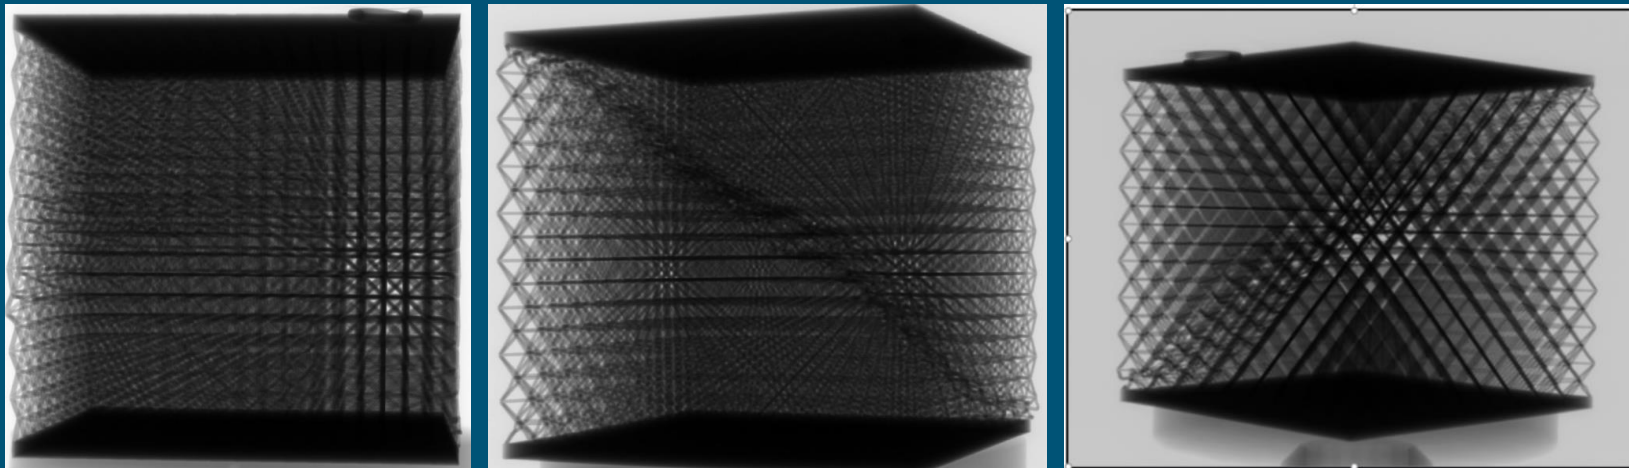
Sample 2: Final Deformation Lattice Rotation

Comparative CT (4D CT) shows lattice structure at various stages of the deformation process (4th dimension).
