Rolling Contact Fatigue (RCF) Characterization Using Electro-Magnetic Field Imaging (EMFI) Technology

Anish Poudel, PhD

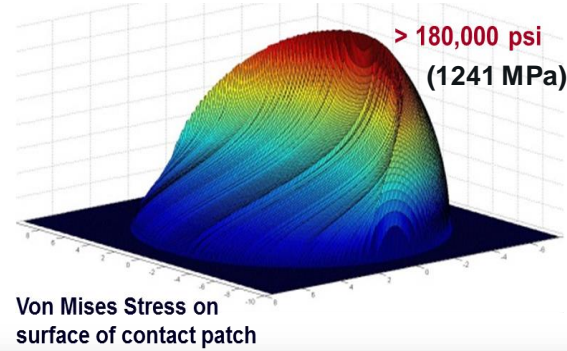
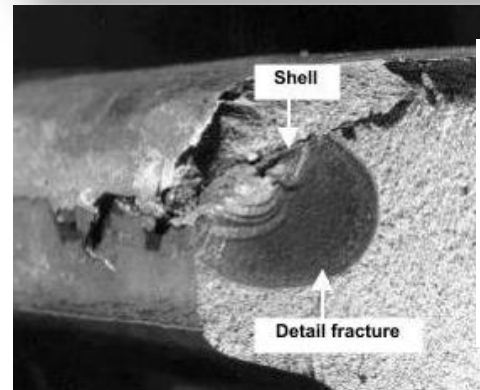
RCF Damage in Rails

- Wheel/Rail Interface: Hertzian contact patch (CP)
 - CP is elliptical, ~10 mm major axis
- Fatigue induced in the CP between the wheel and the rail
 - Rail yield stress always exceeded
- Repeated heavy rolling contact can cause fatigue damage
 - Surface cracks
 - Subsurface cracks

Material response to repeated loading

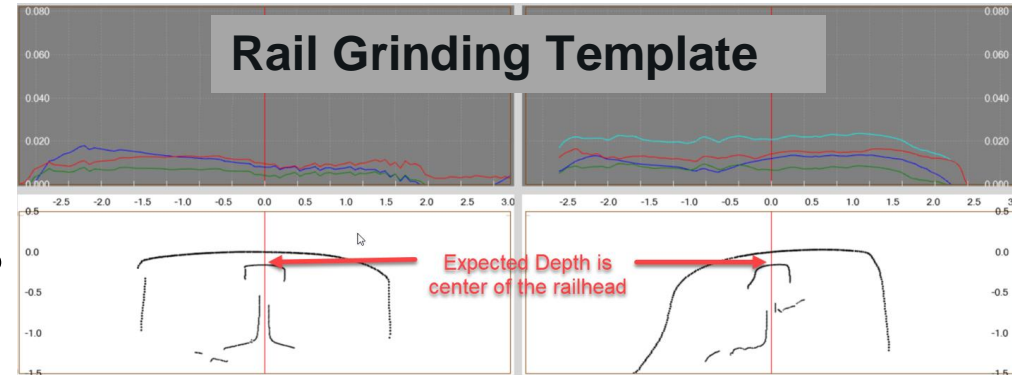
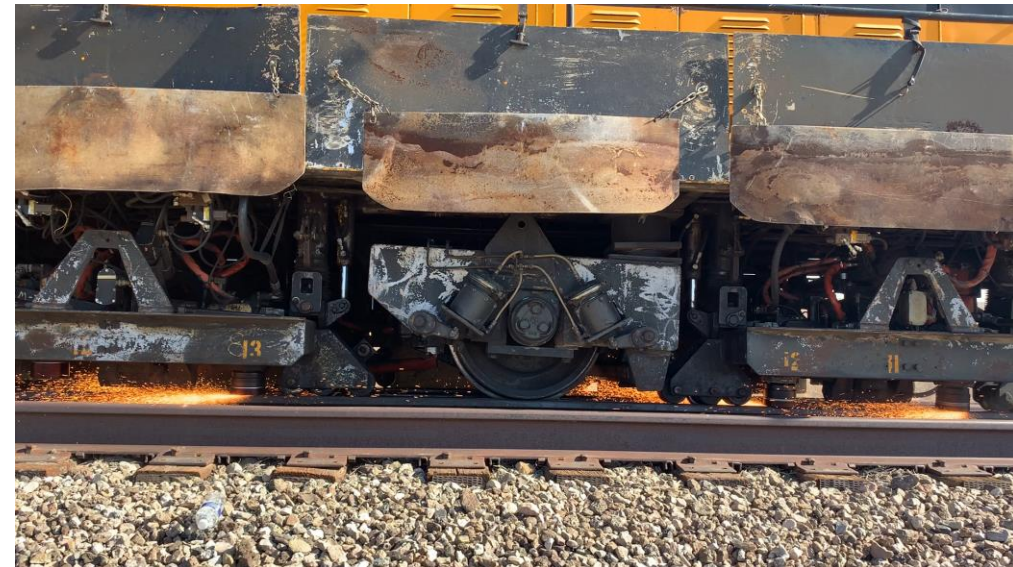
Rail Grinding Operation

- **Preventative approach** for North American Freight Railroads
- Grind frequency is based on Million Gross Tons (MGT)* intervals
- Track segments are grouped based on the tangent and/or mild or sharp curves
- Additional grind passes for “out-of-normal” or “severe” situations
- Challenges:
 - Highly subjective and qualitative (dependent on visual analysis by the operator)
 - Removing too much metal on “good rail”
 - Not removing enough metal on “problem” locations

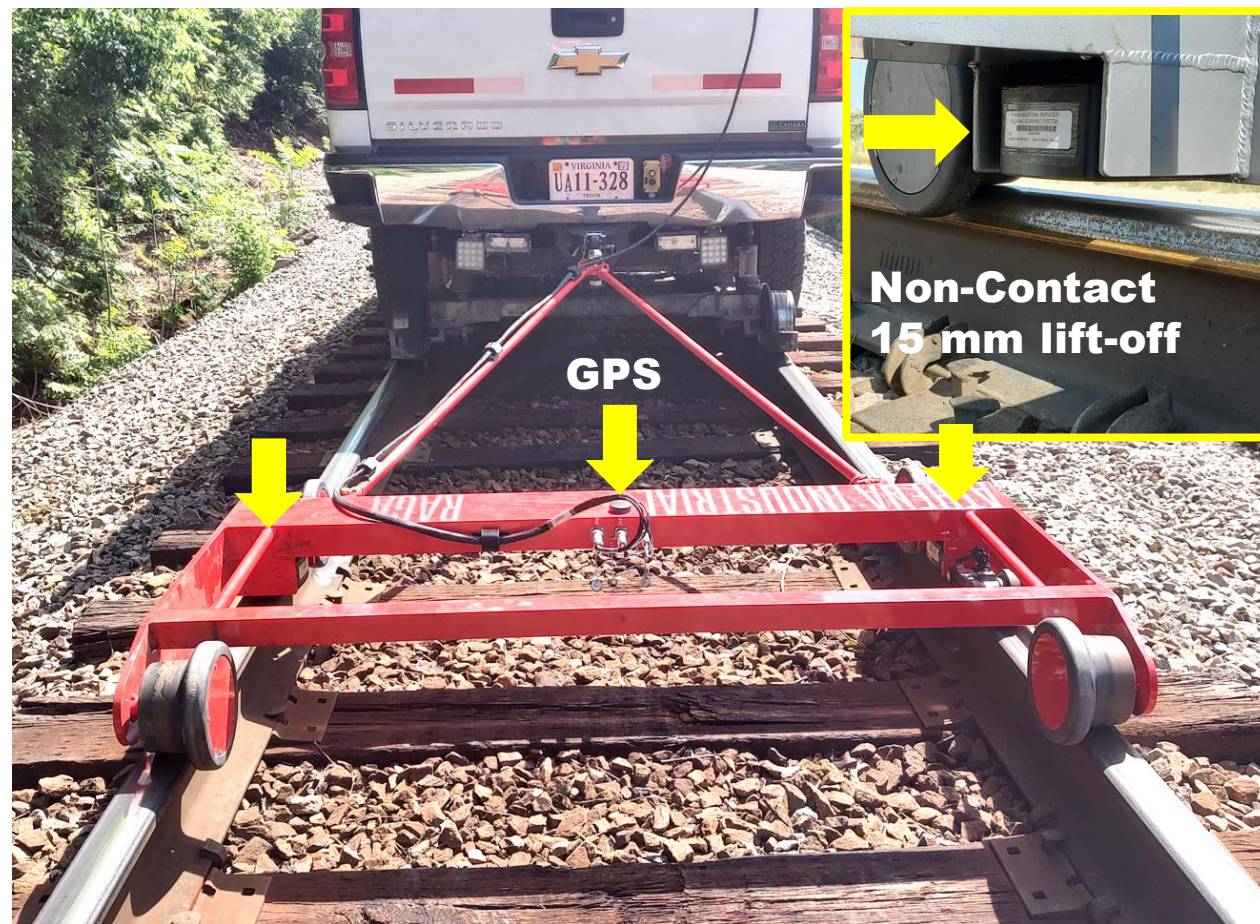
In-motion EMFI System

- Noncontact electromagnetic NDE technique
 - Designed to create a focus EMF to the shape of the object being inspected
 - Measures the position of the mean magnetic field point from the core (i.e., measures distortion of the mean field path)
- Detects surface/ near-surface defects
 - Maps the location and colony or field sizes
 - Measures/analyzes the depth of the defects

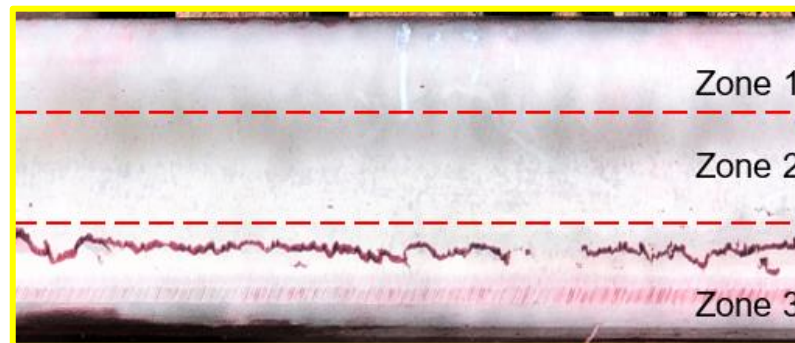
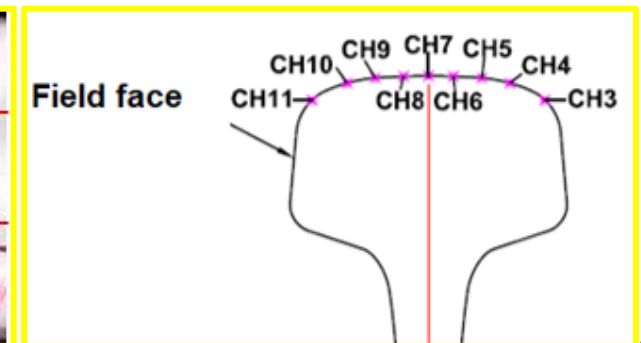
Rails	Zone 1 (Ch. 4, 5)	Zone 2 (Ch. 6,7,8)	Zone 3 (Ch. 9, 10)
High Rail	Field	Center	Gage
Low Rail	Gage	Center	Field

EMFI sensor zones relative to the rail head

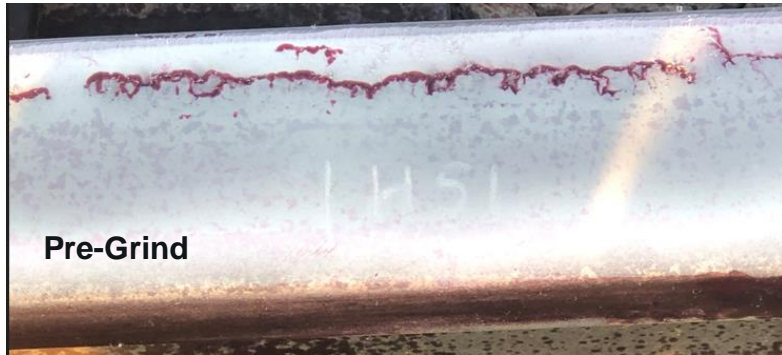
- Residual crack depths were measured using microscope after post-grind
 - Deepest crack remaining for the high rail tie location 263 after grinding was approx. 0.5 mm

PT results for the high rail tie location 263

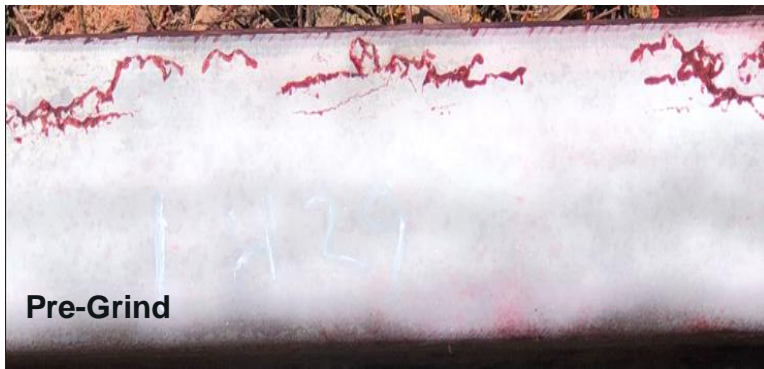
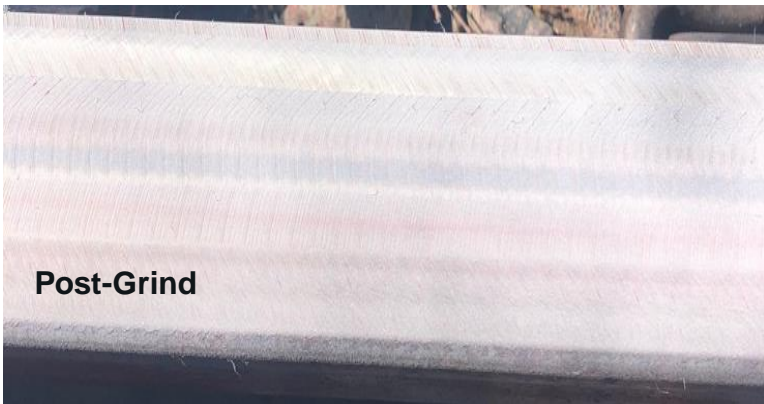
- Deepest crack remaining for the high rail tie location 276 after grinding was approx. 0.4 mm

PT results for the high rail tie location 276

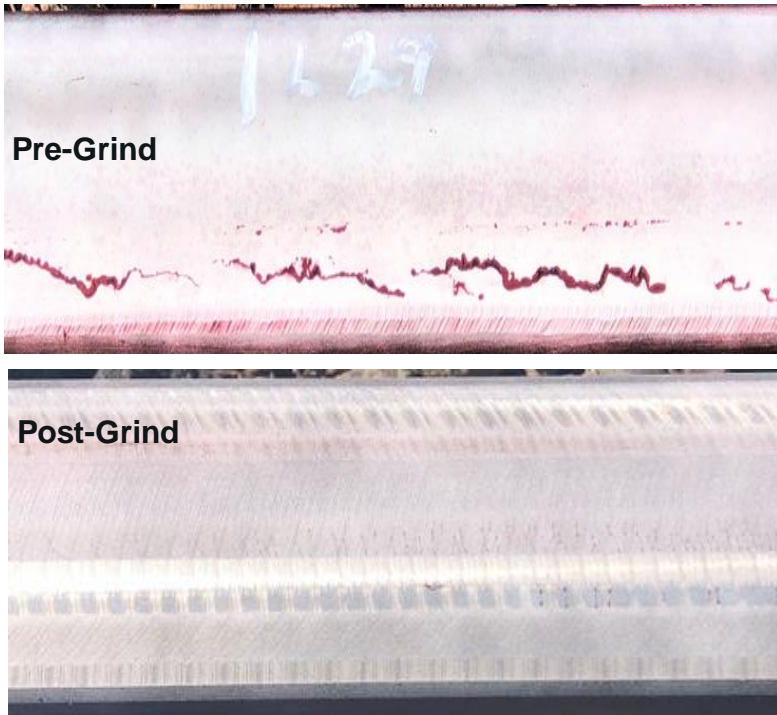
- Residual crack depths were measured using microscope after post-grind
 - Deepest crack remaining for the low rail tie location 276 after grinding was approx. 0.2 mm

PT results for the low rail tie location 276

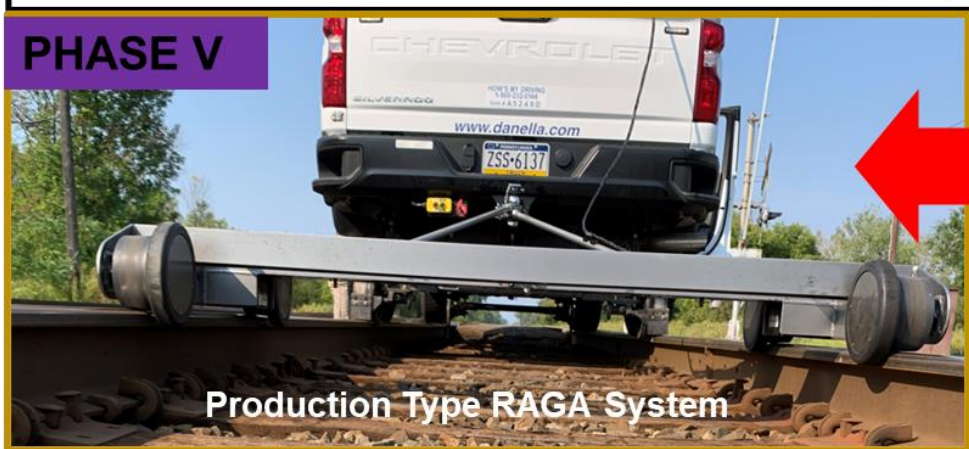
EMFI Technology Roadmap (TRL 2-7)

- Destructive microscopy findings match well with the EMFI post-grind measurements
- RCF crack depth measurements below 0.3 mm are found to be insignificant at the lift-off where the sensor is currently operating. The crack depths within the 0.3 mm regime can be affected by grinding marks and is within the error band of the EMFI sensor
- MxV Rail has recently completed the revenue service trial of the production-type EMFI system
- EMFI technology is ready for implementation in North American Railroads
- This research demonstrated the design, development, testing, and validation of EMFI technology for RCF characterization (TRL 2-7)
